WATERSHED CHARACTERIZATION REPORT

CARR'S CREEK WATERSHED

SEPTEMBER 2012 | FINAL DRAFT

KCI TECHNOLOGIES, INC.
936 RIDGEBROOK ROAD
SPARKS, MD 21152

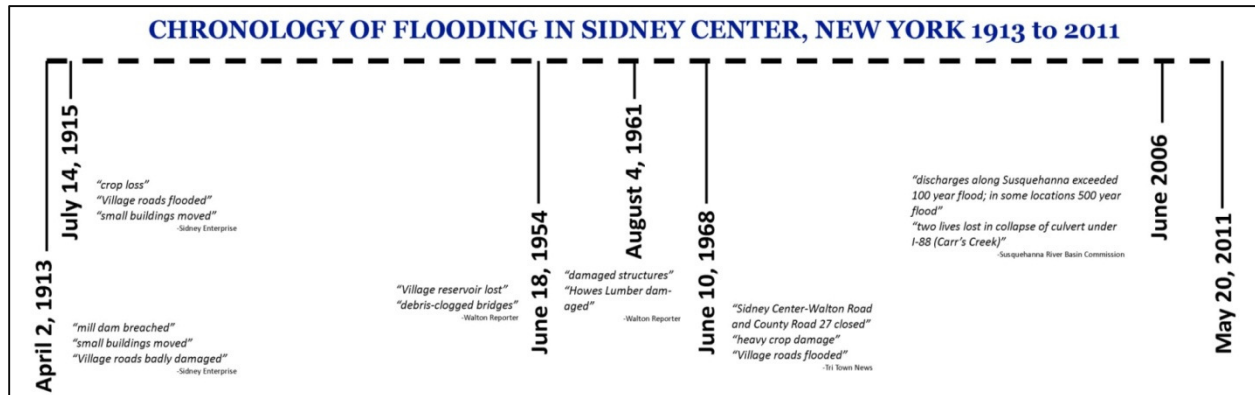
Figure 1 - Flooding Events 1913 to 2011

In addition to these events, Figure 1 below details a chronology of flooding events in Sidney Center from 1913 to 2011.

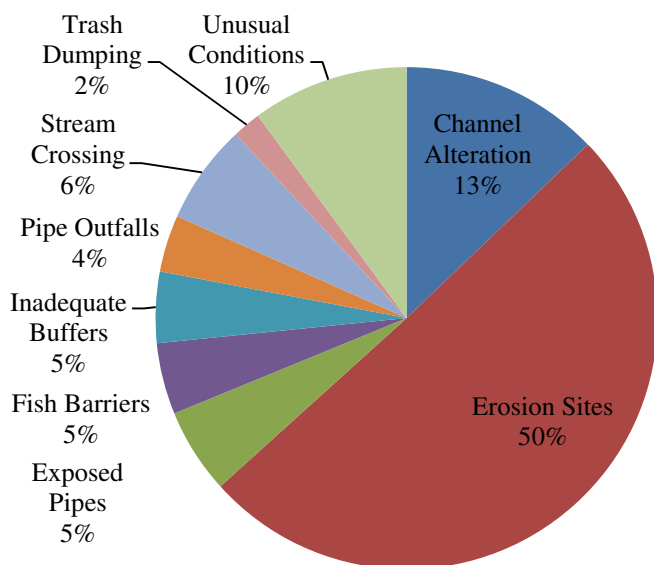
Figure 2 - Stream Corridor Assessment Results

Table 11 - Summary of Sites found in Carr's Creek Watershed during 2008 Stream Corridor Assessment

Channel Alteration	Erosion Sites	Exposed Pipes	Fish Barriers	Inadequate Buffers	Pipe Outfalls	Stream Crossing	Trash Dumping	Unusual Conditions
14	55	6	5	5	4	7	2	11

Channel alteration was observed at 14 sites with the type of material used for the alterations ranging from earth channel to concrete, rip-rap, and steel bridge abutments and the length of channel alterations ranging from 50 feet to 300 feet (Map SC2).

Multiple erosion sites (55 sites) were observed throughout the assessed portions of Carr's Creek and Willow Brook (Map SC3) with the most erosion sites occurring along Carr's Creek adjacent to County Highway 23 near Dunshee Road and adjacent to Franklin Depot Road near Franklin Depot. Eroded bank length ranged from 30 feet to as much as 500 feet to 0.25 miles (1,320 feet) with exposed bank heights ranging from 1 foot to 40 feet. The majority of erosion sites were located on meanders with pasture/crop fields, lawn, shrubs, or small trees within the riparian buffer. Mature trees within the riparian buffer zone help with erosion control as the root systems within the soil add stability to a stream bank.

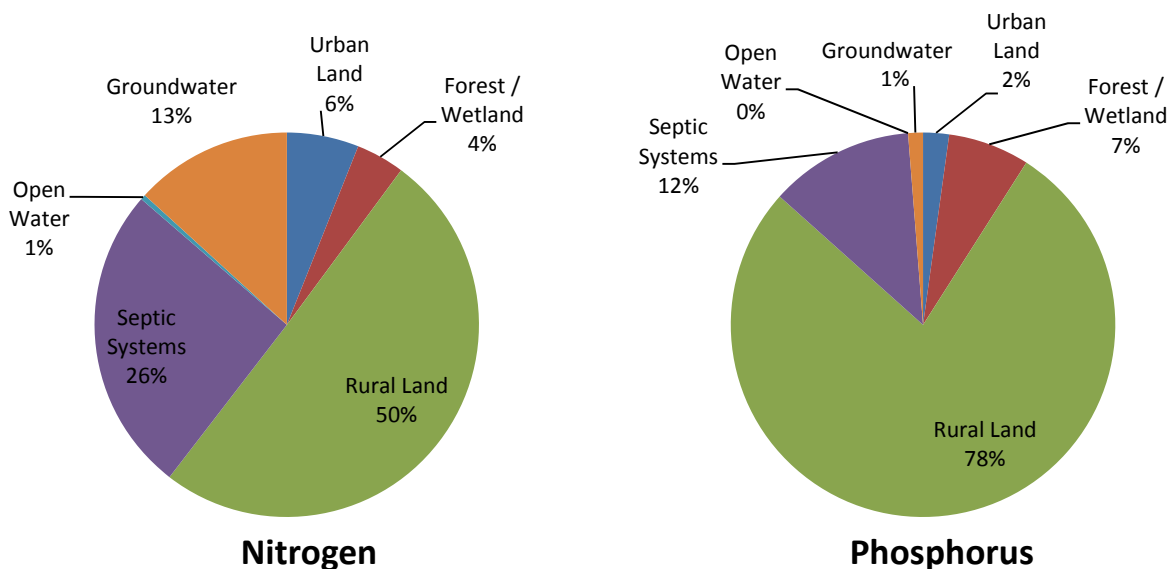
Figure 3 - Nitrogen and Phosphorus Sources

The charts below summarize the results. Fifty percent of the nitrogen loads were from rural sources, and 26 percent was from septic systems, both working and failed. Twenty percent of the load is from uncontrollable sources: groundwater, open water, and forest/wetland.

The majority of the phosphorus load was estimated to be from rural sources. These sources, plus septic systems, accounted for 90 percent of the total. Eight percent of the load was from uncontrollable sources, including groundwater and forest/wetland.

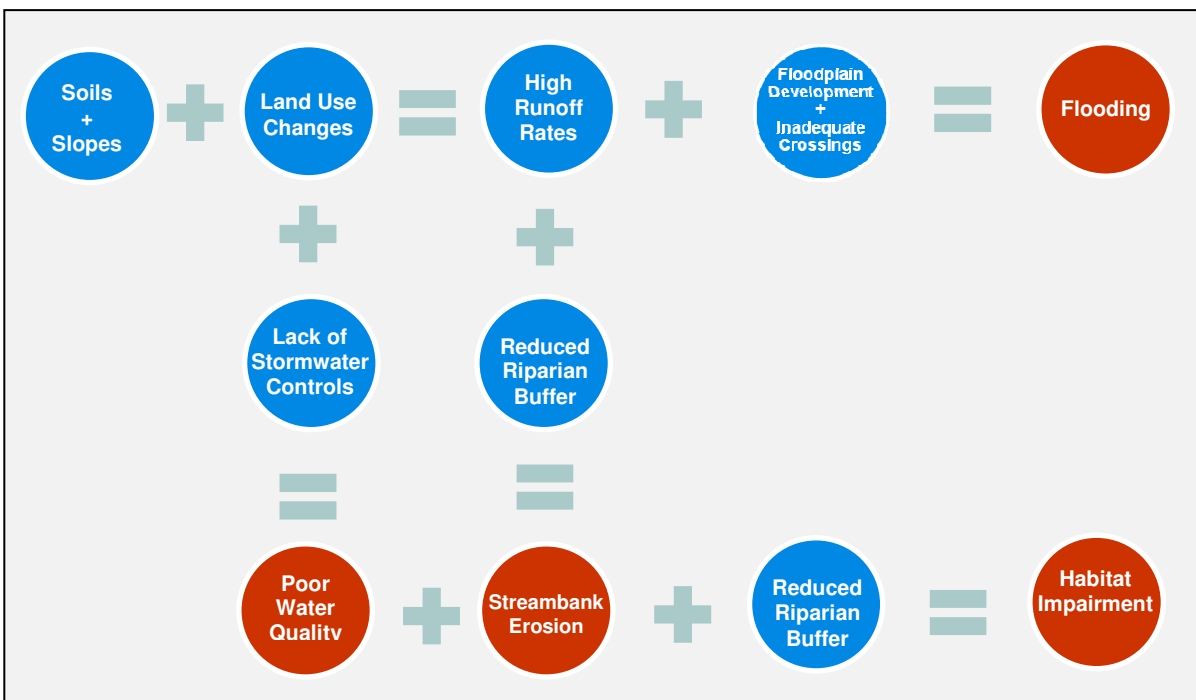
Figure 4 - Watershed Issues Summary

Many of these water quality issues interact with one another, so that an issue which might not be significant on its own may be a factor in causing other, more serious degradation. Figure 4 illustrates this process.

By themselves, soils and slopes may not be a problem in a watershed; however coupled with land use changes such as deforestation or urbanization, they can lead to higher runoff rates. High flows, with poor buffers may be a cause of streambank erosion and habitat impairment. High runoff rates alone in an urbanized area may not be a problem, but if they occur in areas with floodplain development or road crossings that were designed for lower flows, they can lead to flooding problems.

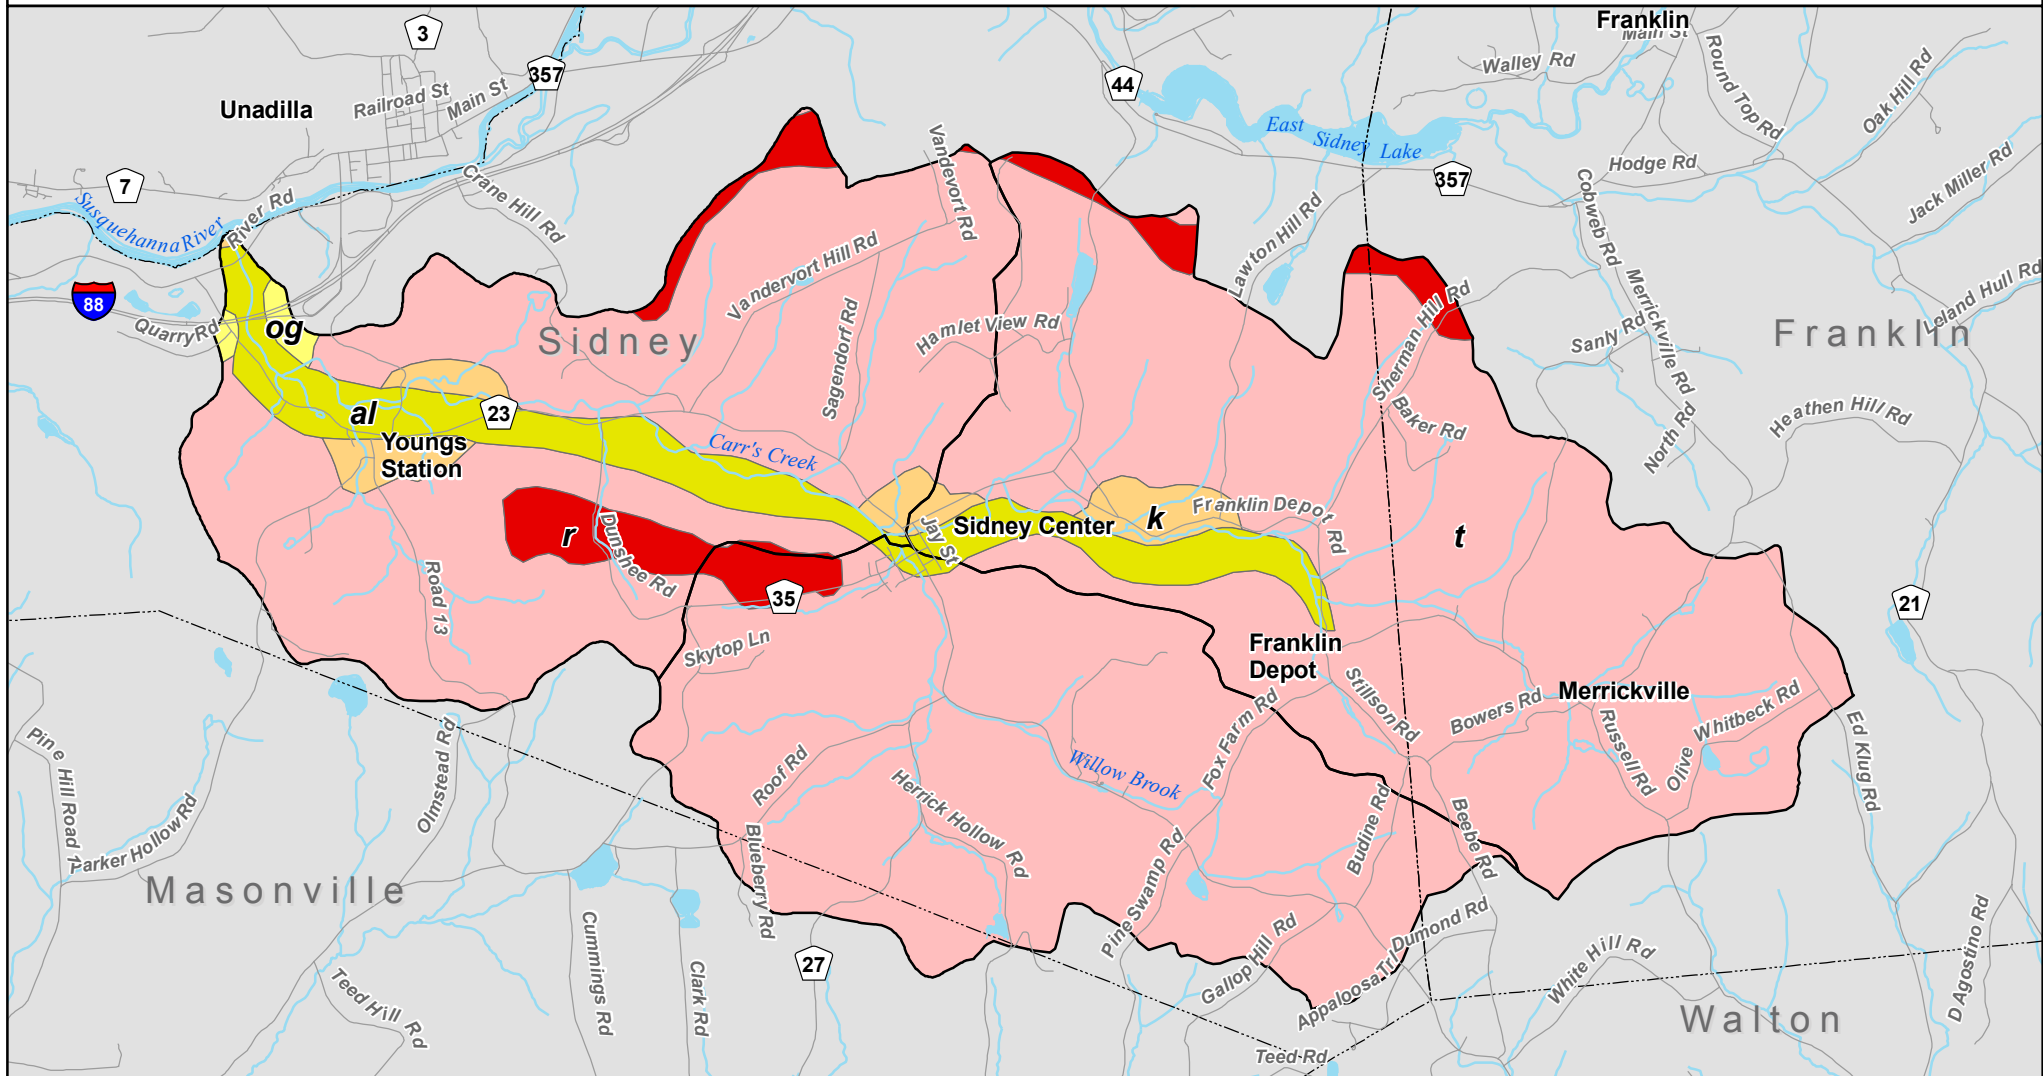
Map 4 - Surficial Geology

t – Till:
Variable texture (e.g. clay, silt-clay, boulder clay), usually poorly sorted diamict, deposition beneath glacier ice, relatively impermeable (loamy matrix), variable clast content—ranging from abundant well-rounded diverse lithologies in valley tills to relatively angular, more limited lithologies in upland tills, tends to be sandy in areas underlain by gneiss or sandstone; potential land instability on steep slopes, thickness variable (1-50 meters)

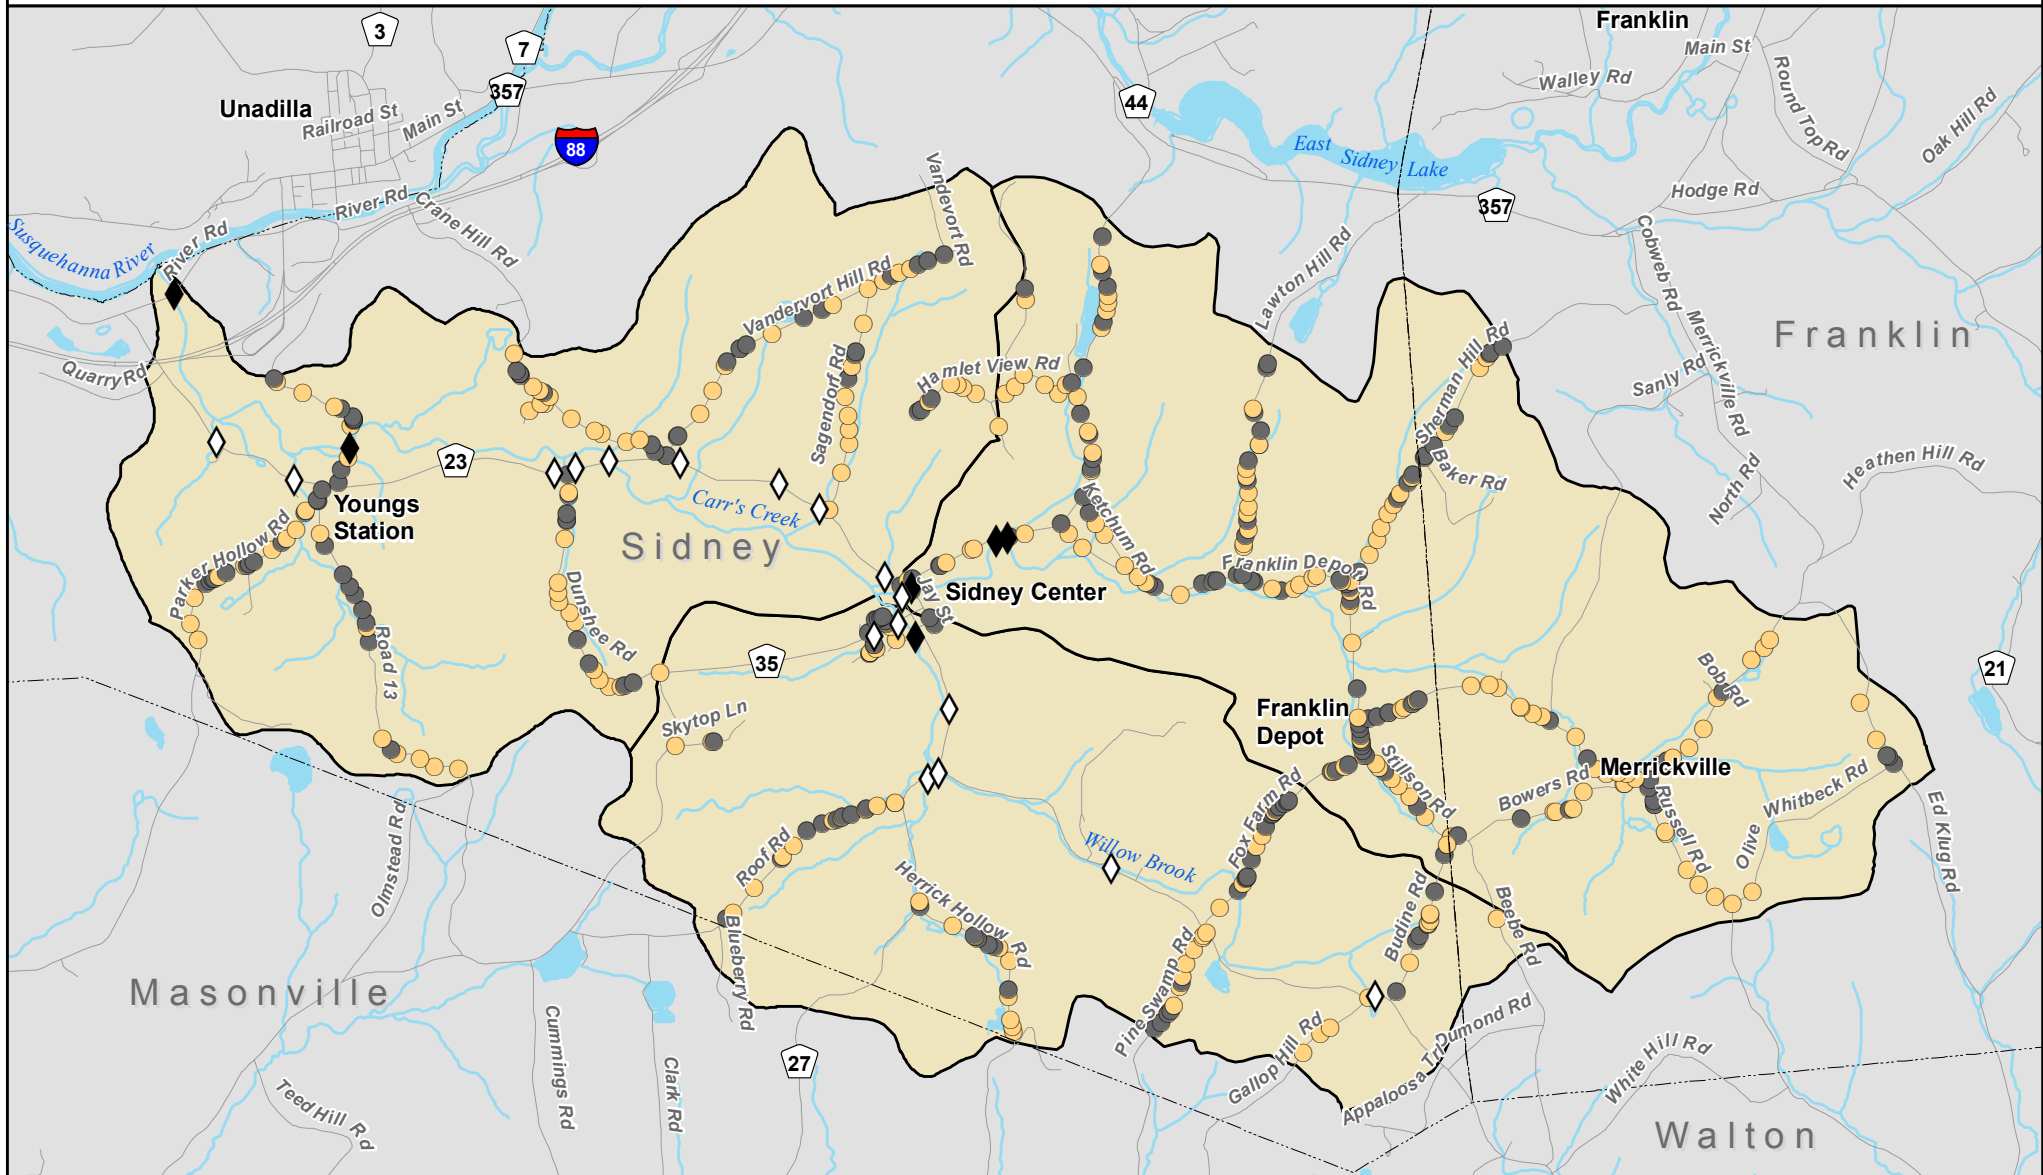
Map 11 - Stream Crossings/Culvert Locations

- ◇ County Bridges
- ◆ Town Bridges
- Cross Pipe
- Driveway Pipe
- Streams
- Carr's Creek Watershed

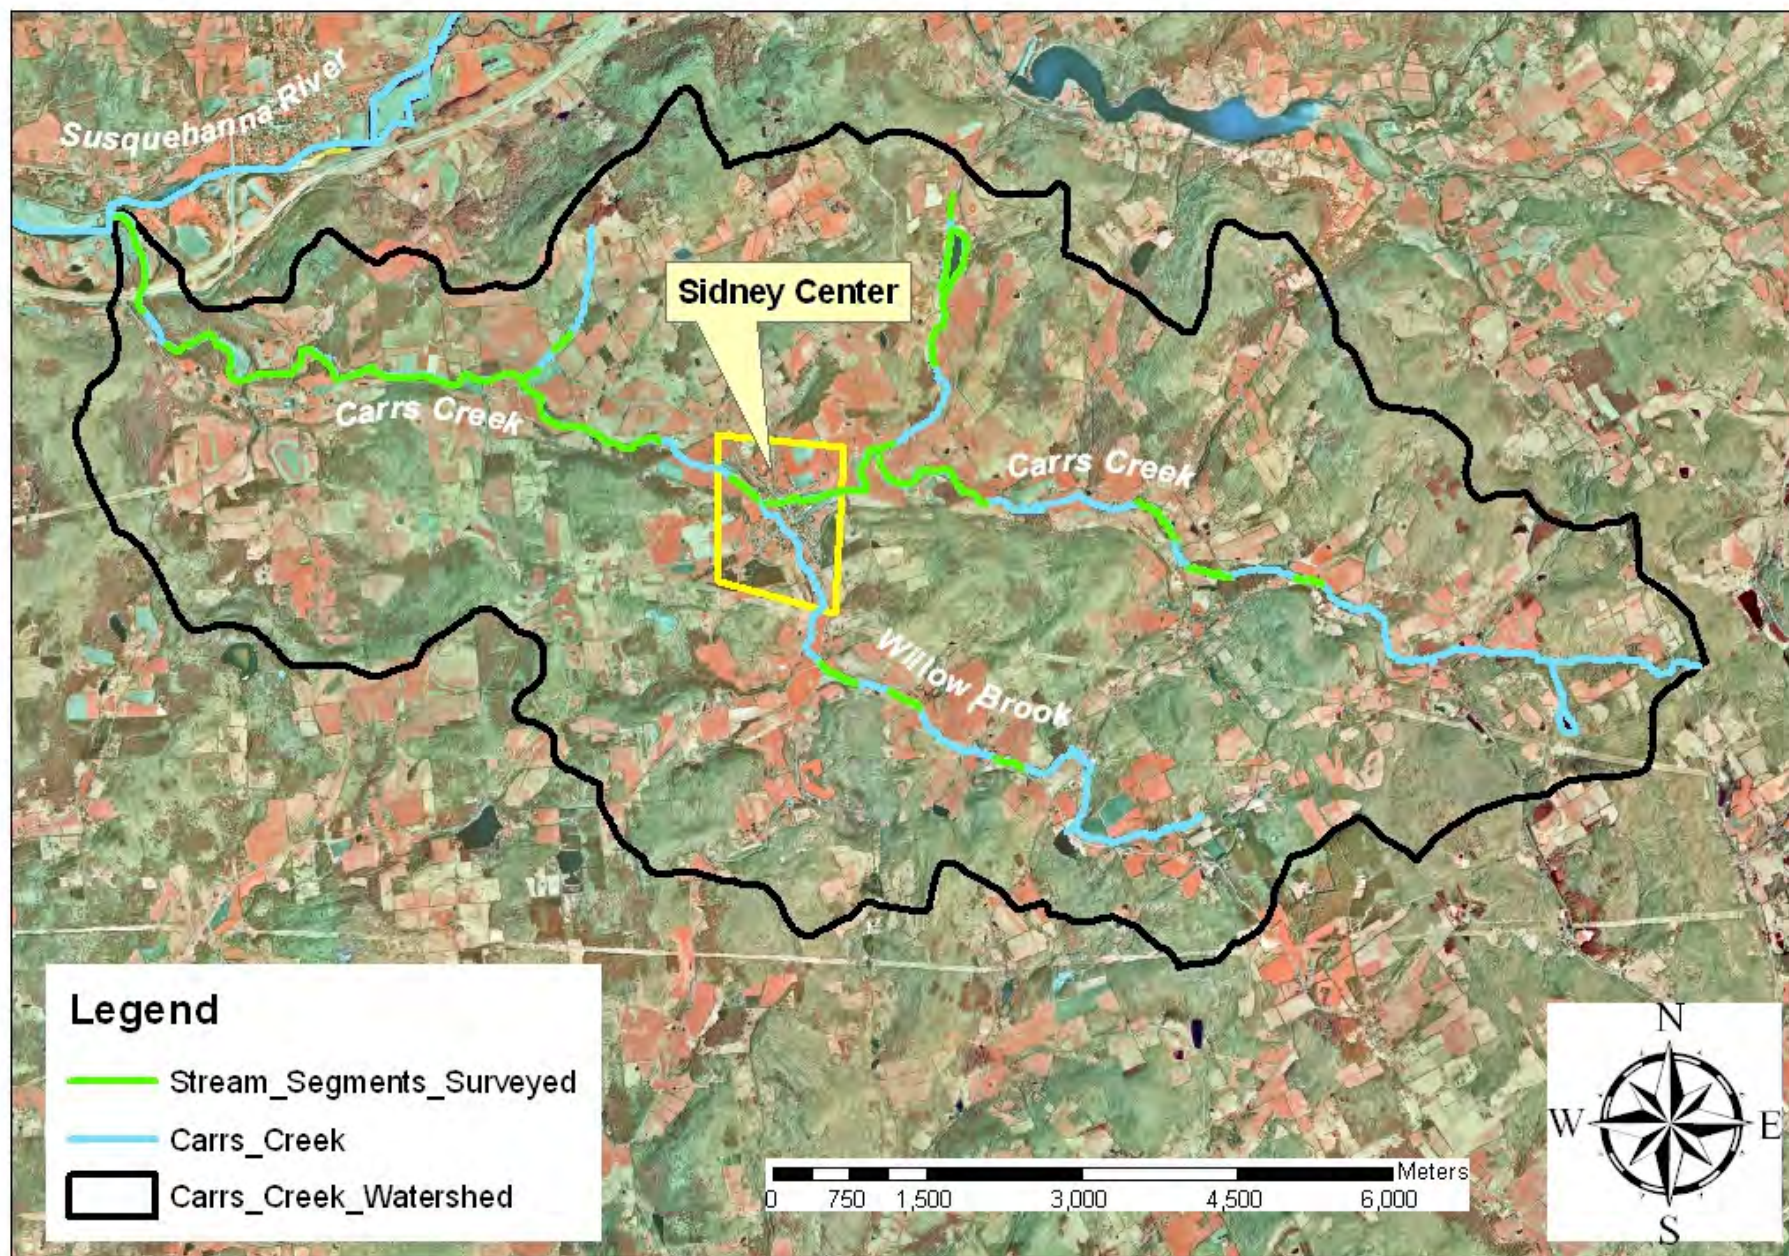
Map SC1

Segments of Carrs Creek Surveyed during 2008 Stream Corridor Assessment

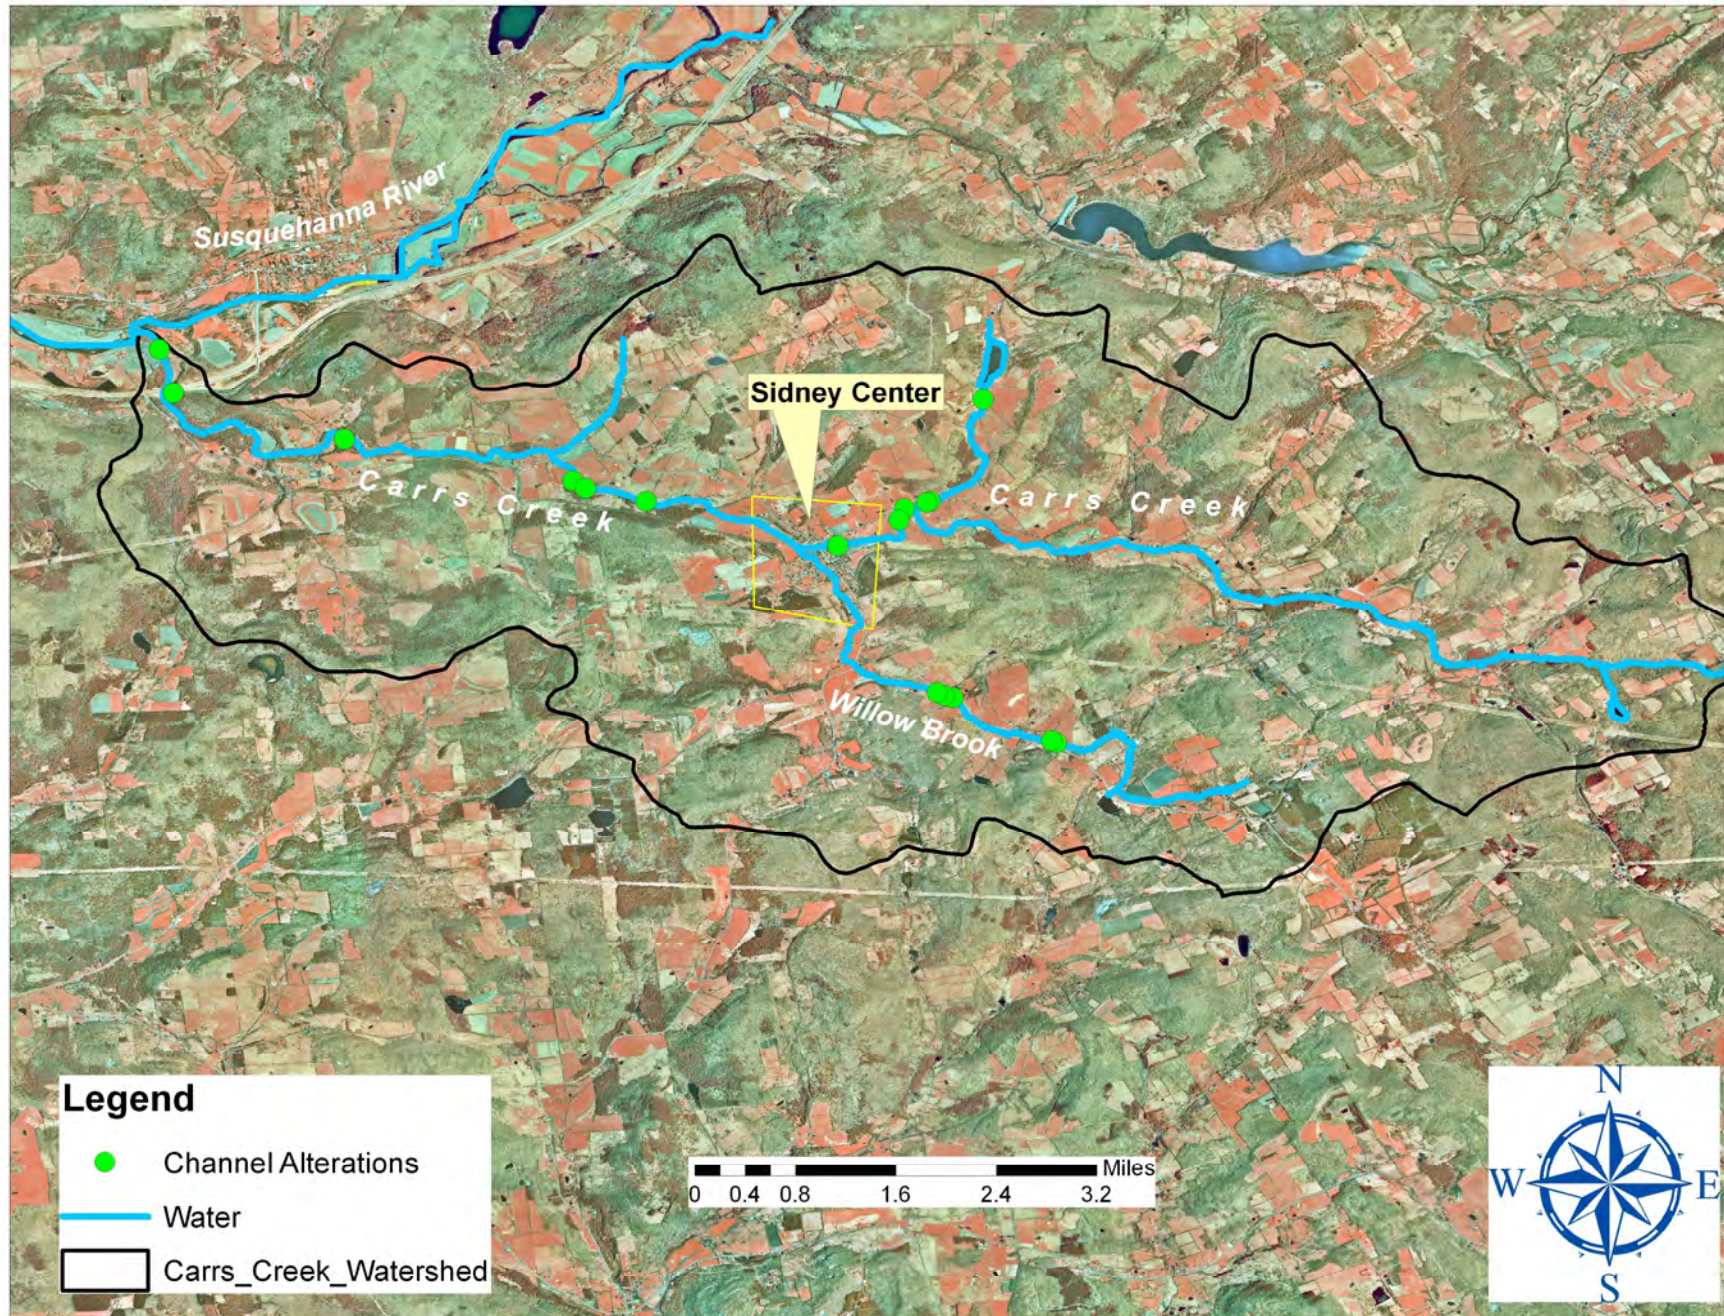
Map SC2

Channel Alteration Sites found in Carrs Creek Watershed during 2008 Stream Corridor Assessment

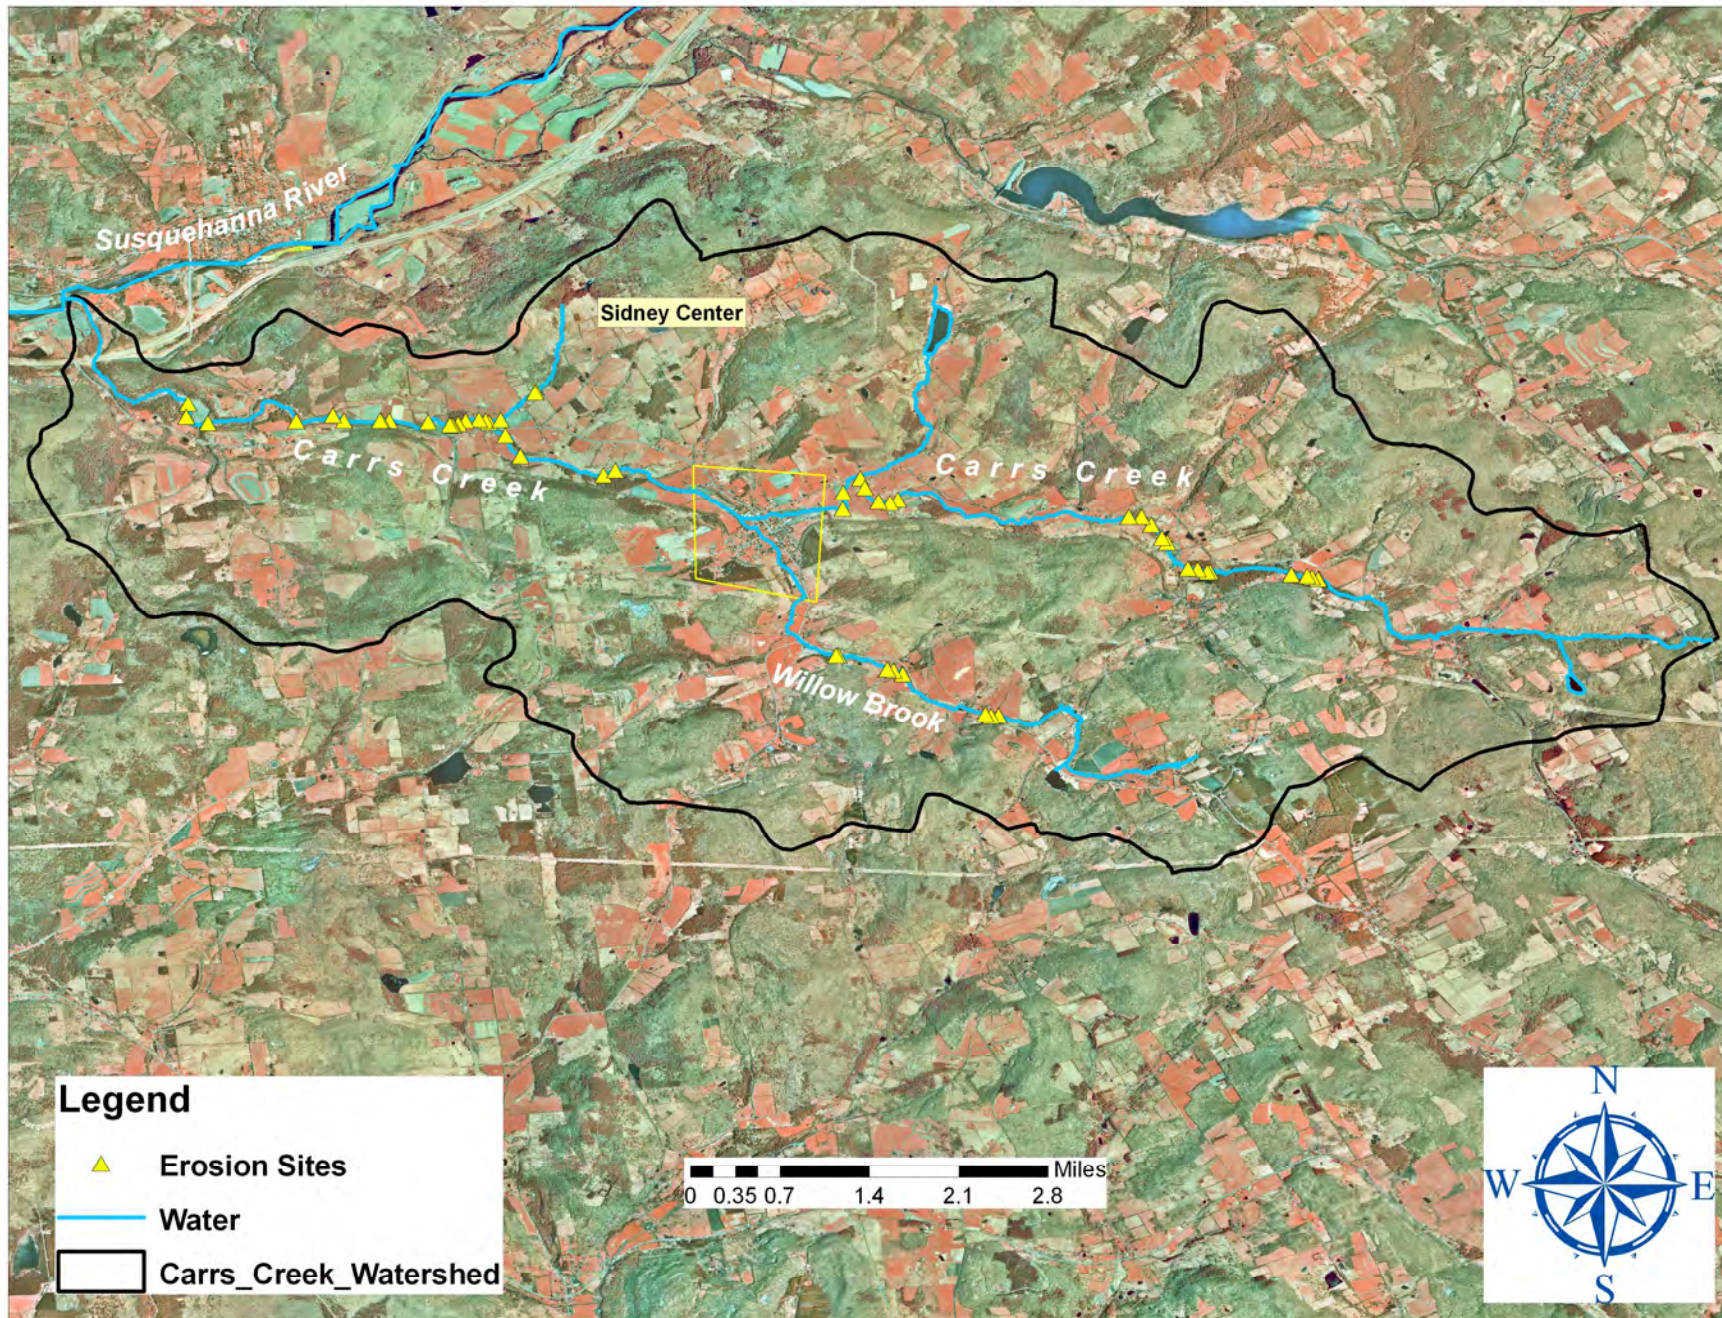
Map SC3

Erosion Sites found in Carrs Creek Watershed during 2008 Stream Corridor Assessment

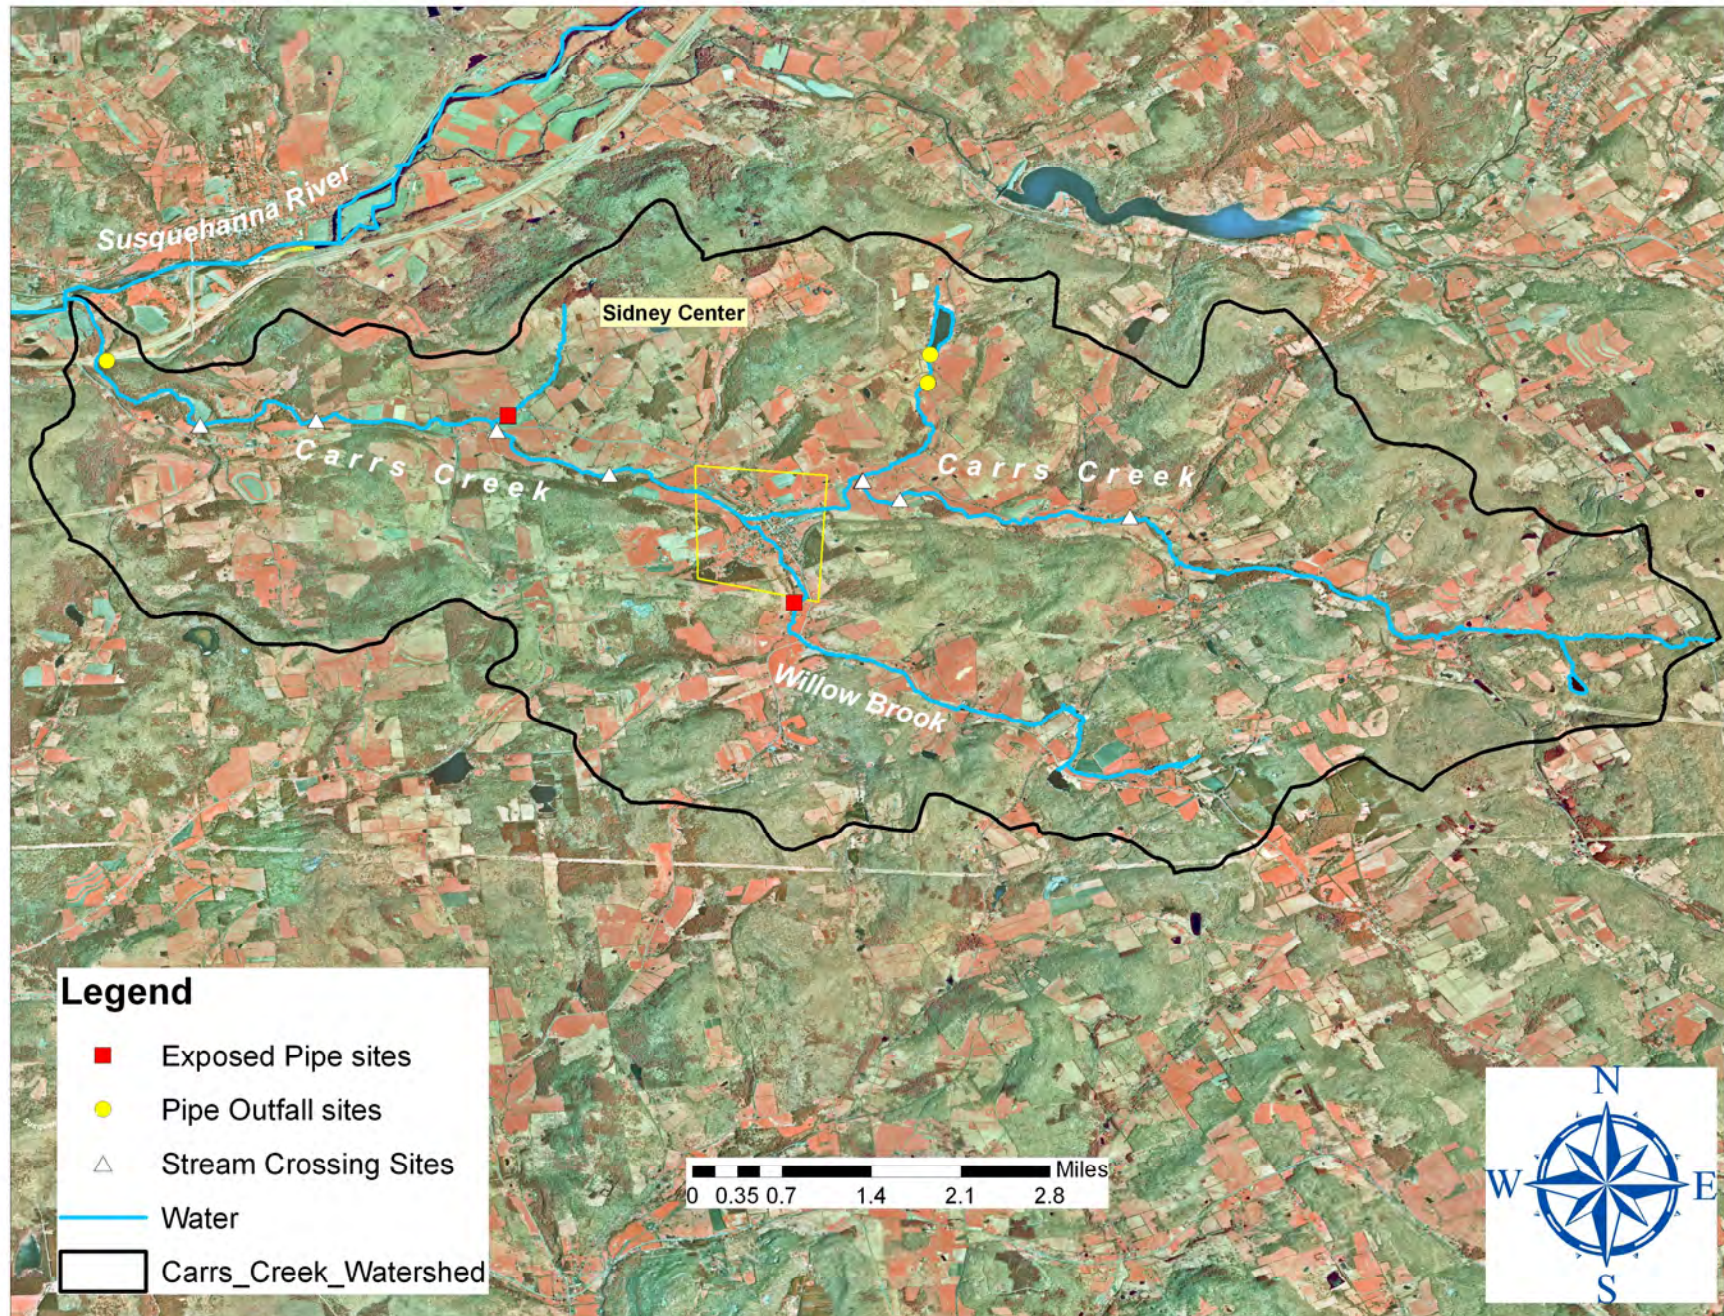
Map SC4

Exposed Pipe, Pipe Outfalls, and Stream Crossing Sites found in Carrs Creek Watershed during 2008 Stream Corridor Assessment

As shown in Map SC4, few exposed pipes (6) and pipe outfalls (4) were observed throughout the Carr's Creek watershed. Seven stream crossings were found primarily along the main tributary of Carr's Creek and generally consisted of informal vehicle crossings, county bridges, and in one instance, a bridge for cattle crossing. All stream crossings were considered to be causing minimal to no impact to the stream.

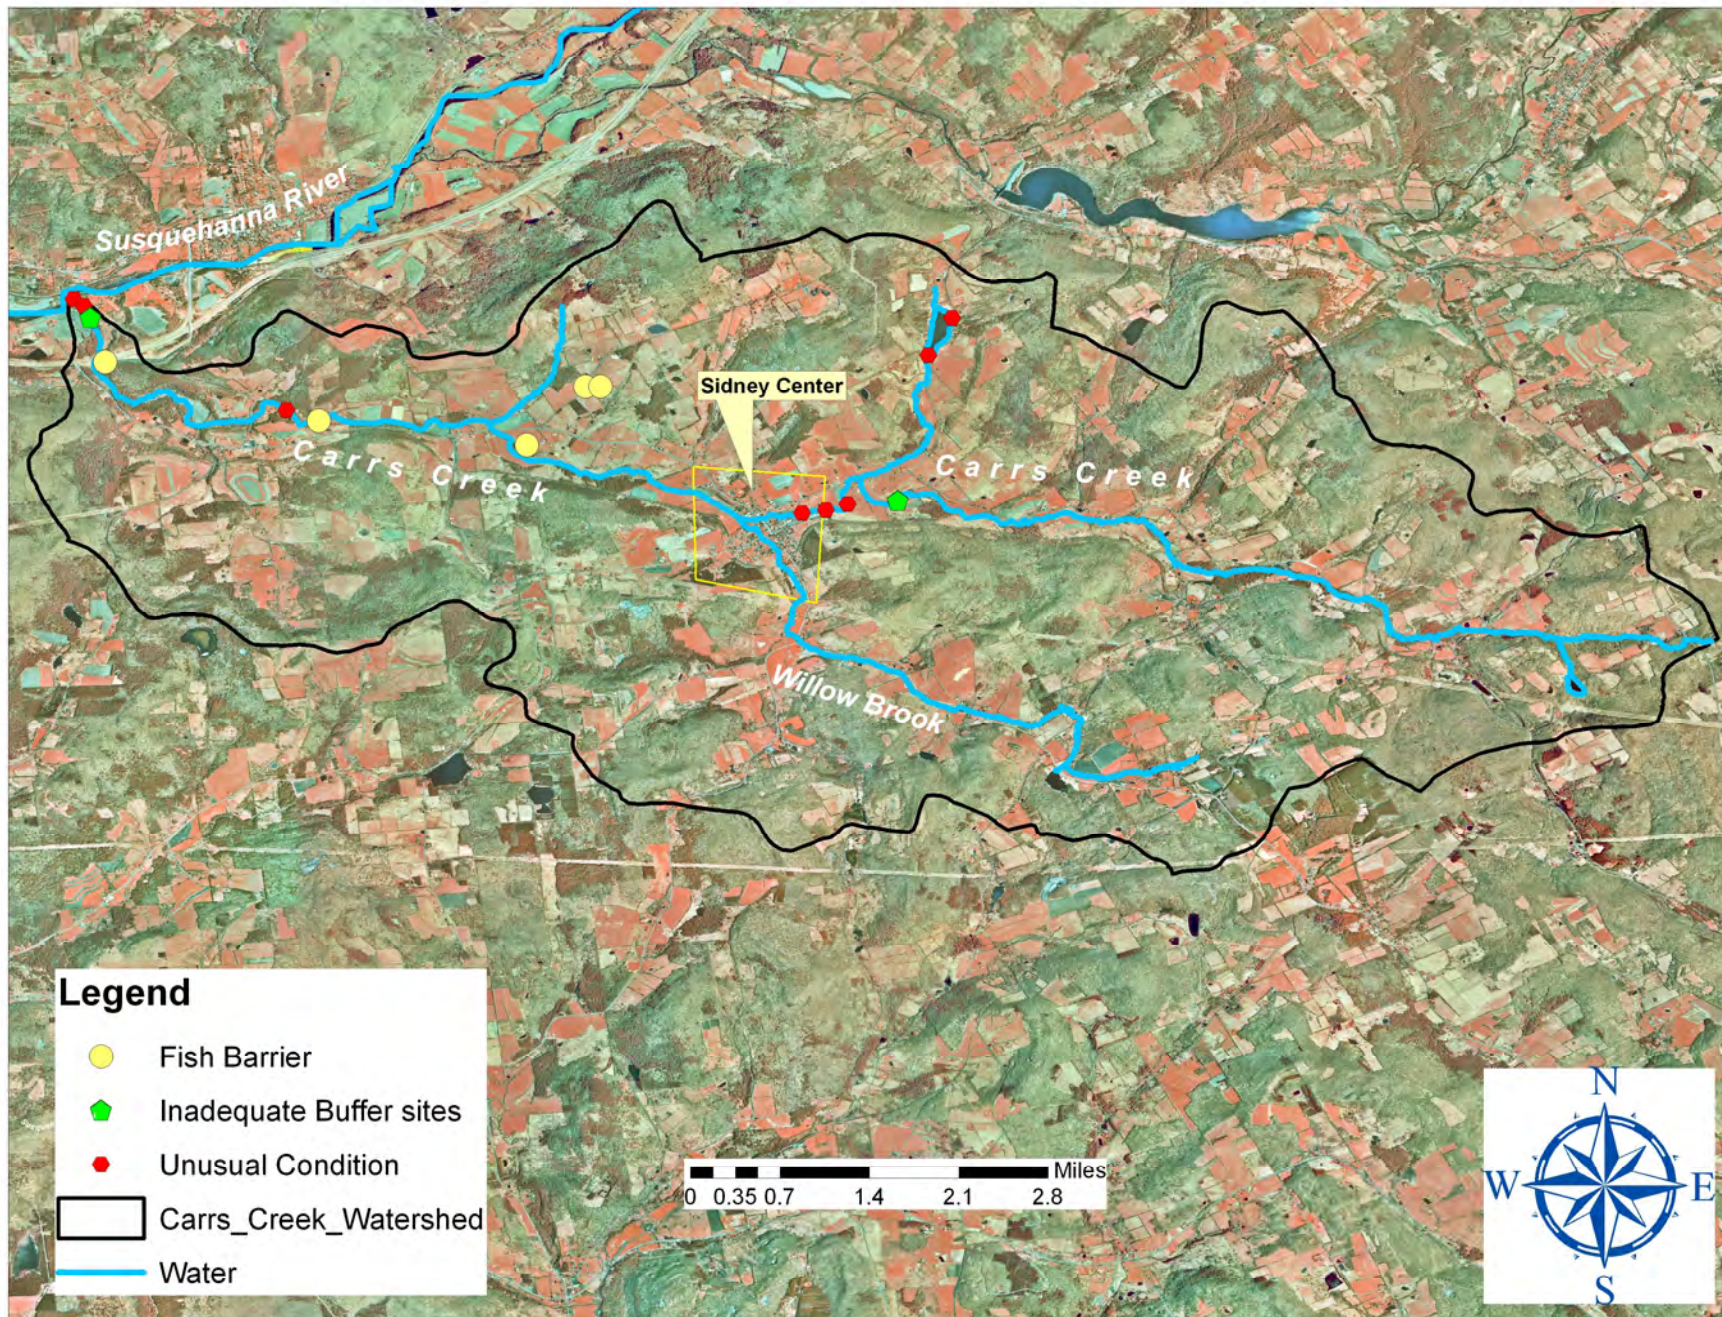
Fish Barriers, Inadequate Buffer, and Unusual Condition Sites found in Carrs Creek Watershed during 2008 Stream Corridor Assessment

Map SC5 presents Stream Corridor Assessment data for fish barriers, inadequate buffer, and unusual conditions found in Carr's Creek watershed. Five fish barriers were recorded; all sites were located along the downstream portion of Carr's Creek. Observed fish barriers included fallen trees in stream, beaver dams, dry channels, and boulder blockages. Due to the prominent agricultural land use found along Carr's Creek and Willow Brook (27 percent pasture/hay, Table 8, Section 2.7.1), inadequate buffers were observed throughout the watershed.

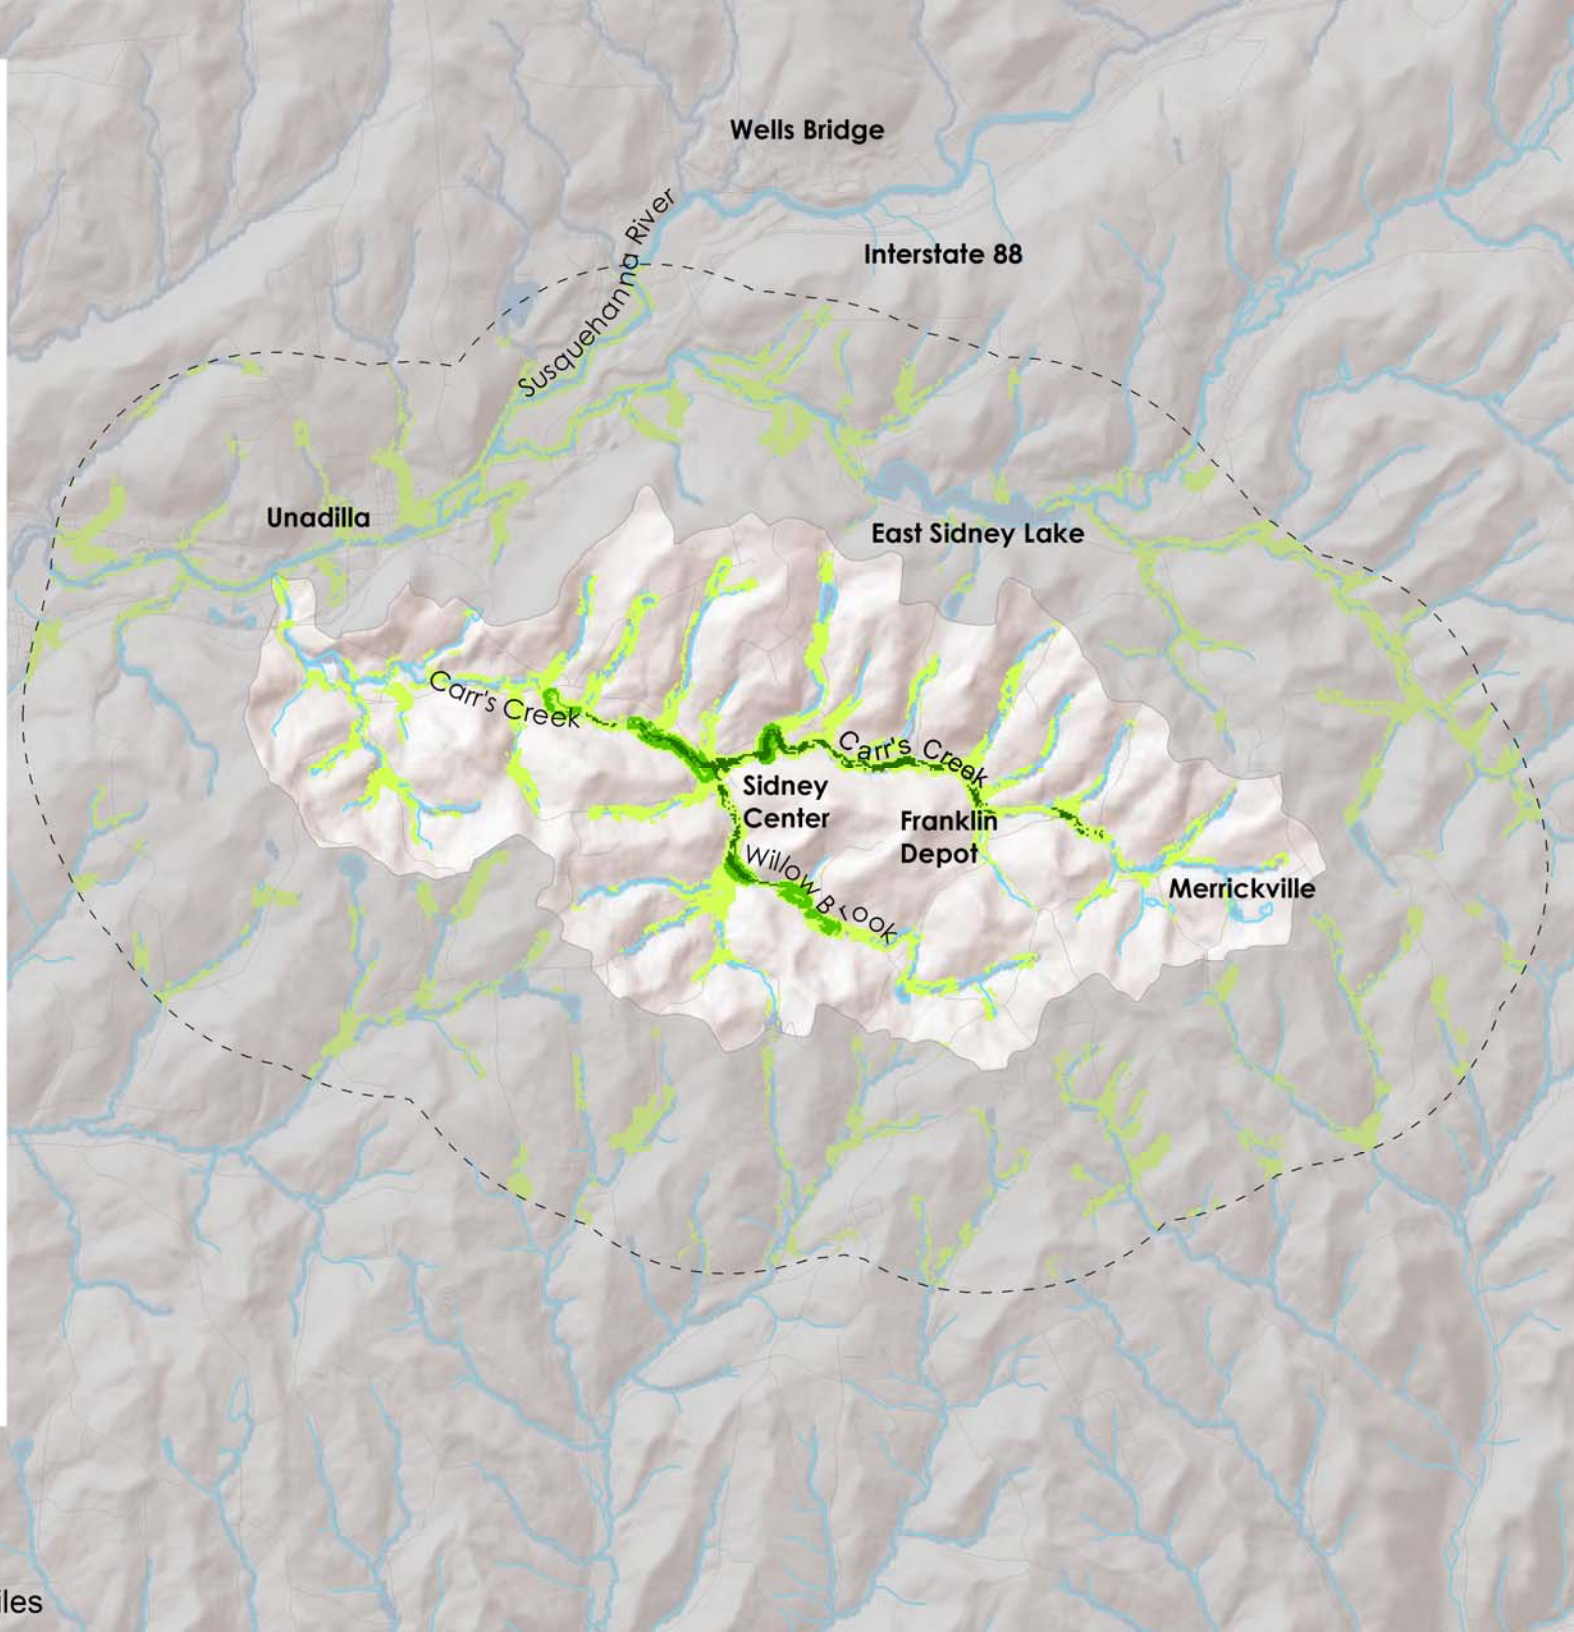
1. Lack of existing riparian buffers
2. Invasive species (not mapped)
3. Adjacent pollution sources
4. Livestock in streams

Maps: Theoharides Consulting, July 2012
 Projection: UTM 18N NAD 1983
 Data sources for Buffers:
 National Land Cover Dataset (NCLD, 2011)
 Streams (KCI, 2011)
 Personal Communication, Wink Hastings, 2012

Five sites were noted during the stream assessment with inadequate buffer. Forested stream buffers are desirable for a number of reasons. They provide shade for the streambed, which helps keep water temperature from increasing. Higher temperature reduces dissolved oxygen, which in turn, affects sensitive species. Leaves, woody debris, and detritus from the buffer also provide habitat and a food source for species on the bottom of the food chain, leading to improved biodiversity. Finally, root systems from buffer vegetation help anchor soil on stream banks, reducing or preventing erosion.
