WATERSHED CHARACTERIZATION REPORT

CARR'S CREEK WATERSHED

SEPTEMBER 2012 | FINAL DRAFT

KCI TECHNOLOGIES, INC.
936 RIDGEBROOK ROAD
SPARKS, MD 21152

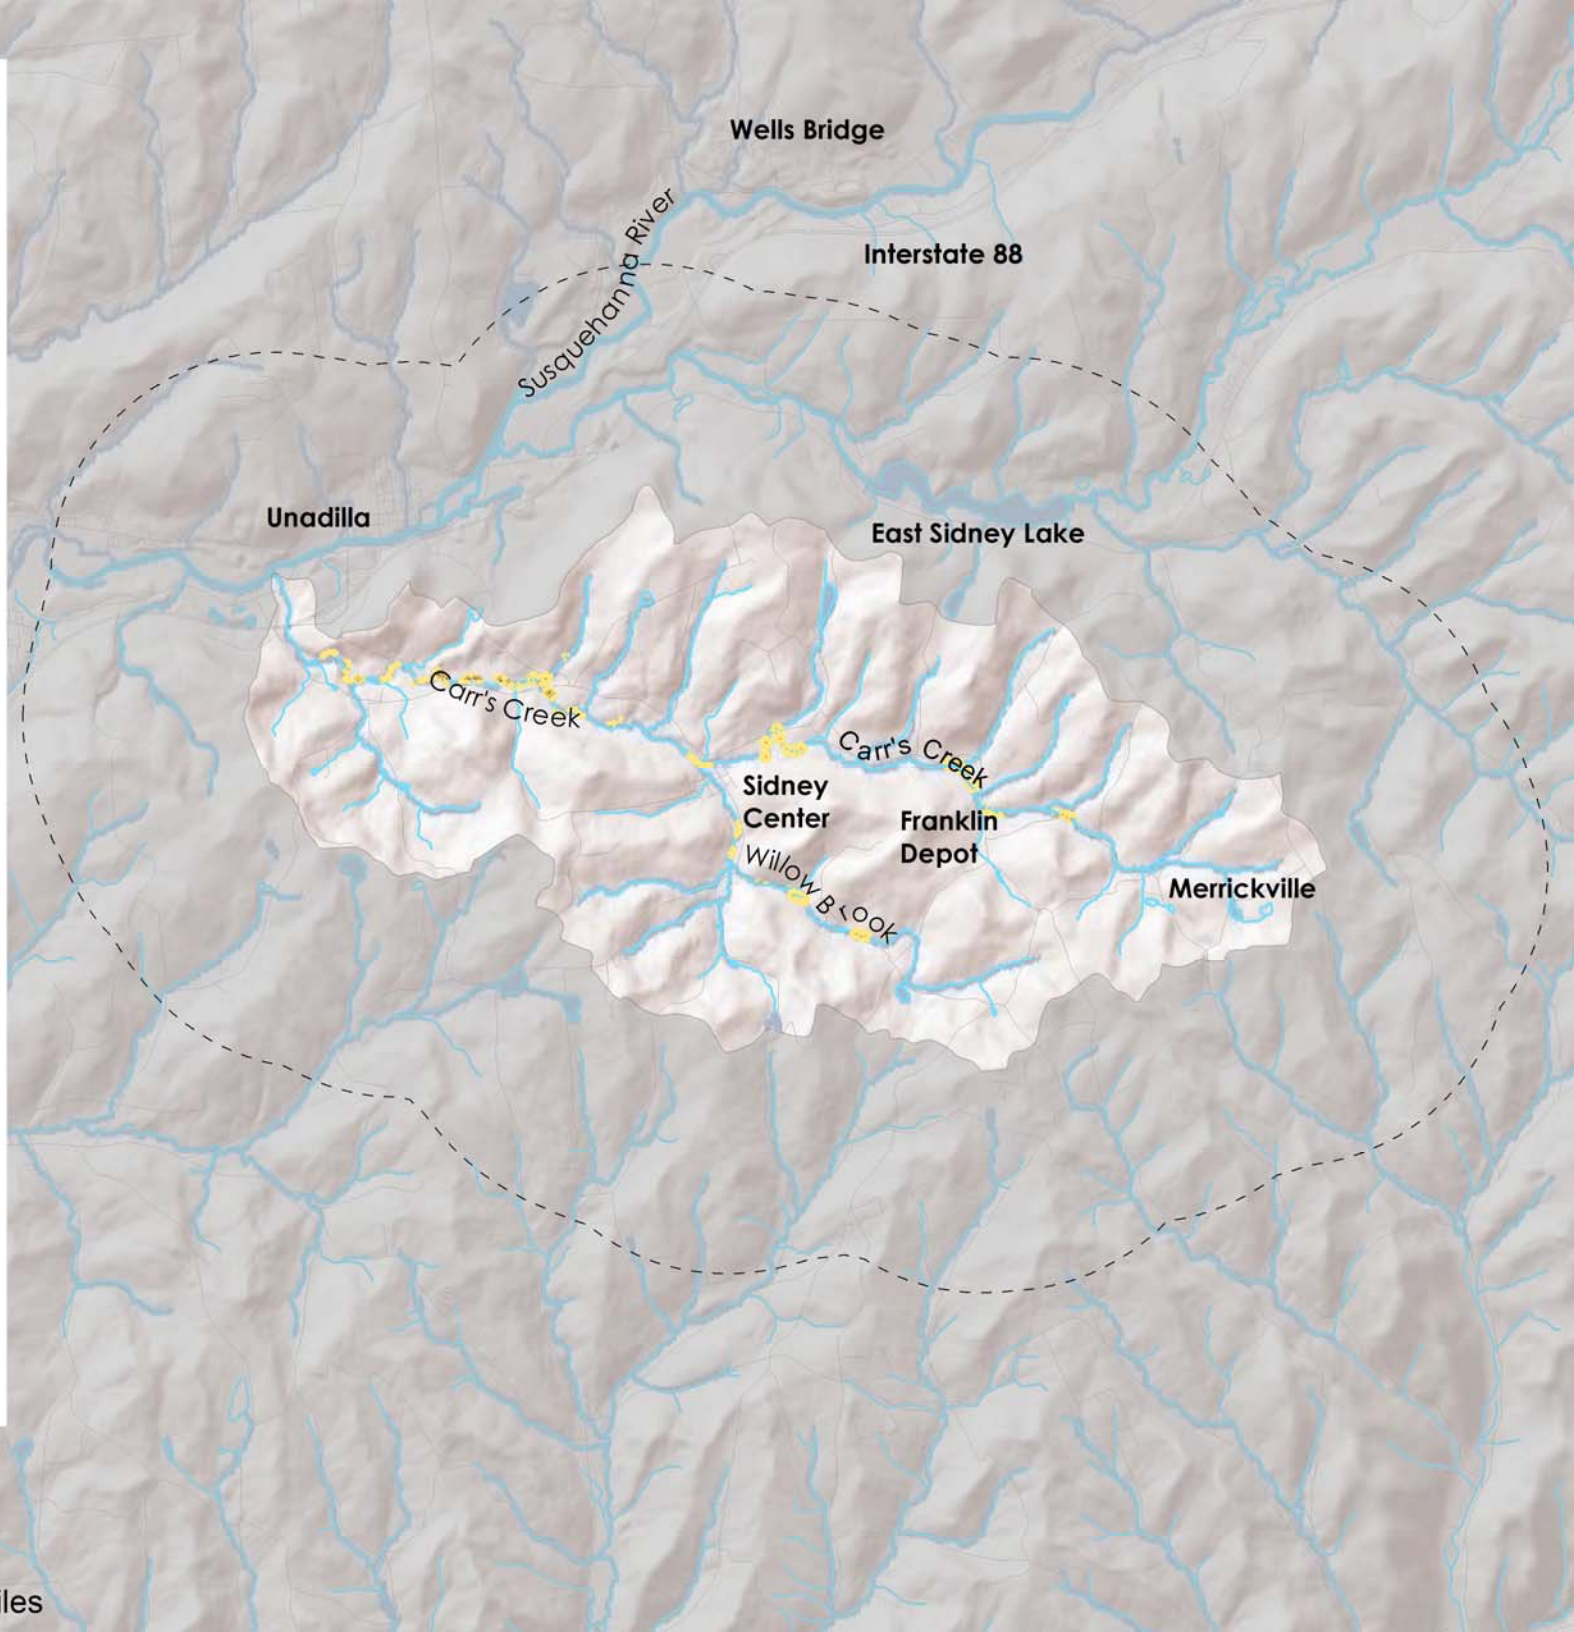
1. Property impacted by erosion
2. Priority areas for shoreline stabilization
3. Length of bank erosion
4. Height of bank erosion

Maps: Theoharides Consulting, July 2012
 Projection: UTM 18N NAD 1983
 Data sources for Erosion:
 National Land Cover Dataset (NCLD, 2011)
 Streams (KCI, 2011)
 Stream Corridor Assessment Data (KCI, 2011)

Multiple erosion sites (55 sites) were observed throughout the assessed portions of Carr's Creek and Willow Brook (Map SC3) with the most erosion sites occurring along Carr's Creek adjacent to County Highway 23 near Dunshee Road and adjacent to Franklin Depot Road near Franklin Depot. Eroded bank length ranged from 30 feet to as much as 500 feet to 0.25 miles (1,320 feet) with exposed bank heights ranging from 1 foot to 40 feet. The majority of erosion sites were located on meanders with pasture/crop fields, lawn, shrubs, or small trees within the riparian buffer. Mature trees within the riparian buffer zone help with erosion control as the root systems within the soil add stability to a stream bank.
